Rudder bearings are in issue for all the J40s. The lower bearings originally manufactured by Harken either have failed or will fail due to corrosion. Fortunately, there are two manufacturers now making replacement bearings-Jefa, imported by PYI, is an upgraded bearing similar to the original; Edson Corporation also makes a replacement bearing with integral seals instead of the original packing gland. To help those facing decisions on replacement, I have included some correspondence from J owners who have replaced bearings, and also information from each manufacturers representatives. I am also in contact with a J37 owner who is replacing with the Edson bearing and will update with his experience when available. For those who have replaced their bearings and have comments on the installation and/or the installation, please email a writeup (pictures if possible) and I will add it to the material here.

*****NEW***October 2008--MAL DE MER III second rudder bearing replacement**

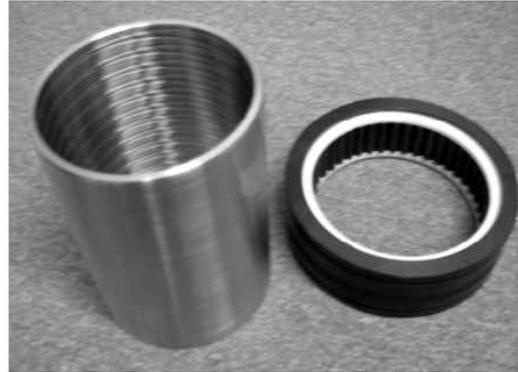
J-120 Lower Bearing- Large ID roller bearing.
The bearing is shipped with a stainless steel sleeve to bond to the rudderpost. The sleeve is the same height as the stock unit. You will need to keep the existing sealing system in place.
Bearing part #0641J120, OD=8.49",
Height=2.75", Sleeve height=9".

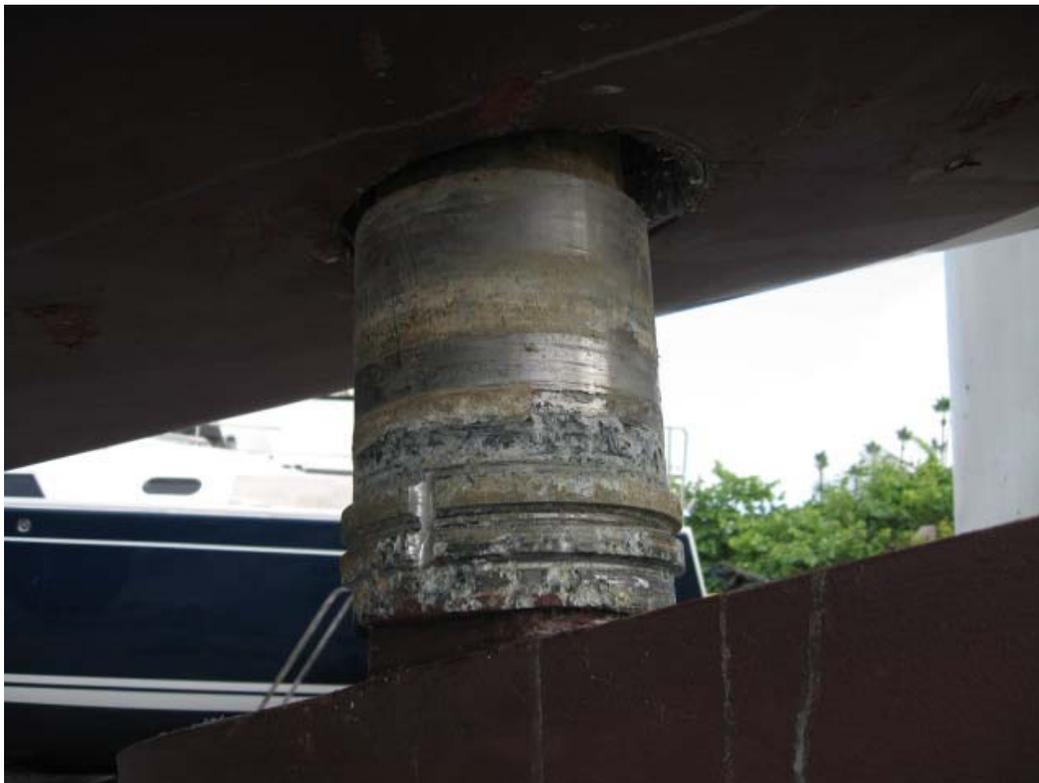
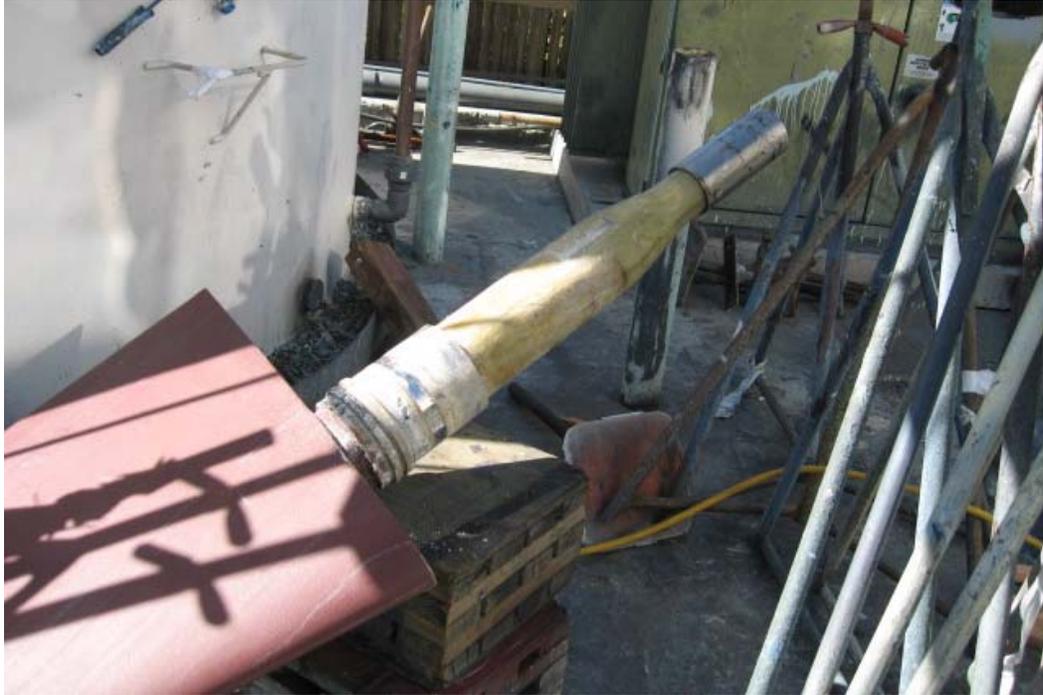
Removing the rudder and lower bearing provided the next surprise. The Harken bearing was frozen in the hull, so had to be drilled out. For those who don't know, there is a lip on the Harken bearing that covers the SS sleeve and makes it impossible to get the rudder out unless you can get the bearing out first- pounded, drilled, or however.

As you can see from the figures above, the rudder came out with half the bearing still attached after a whole lot of drilling, chiseling and cursing. But then it could be cut off of the rudder to start the replacement.

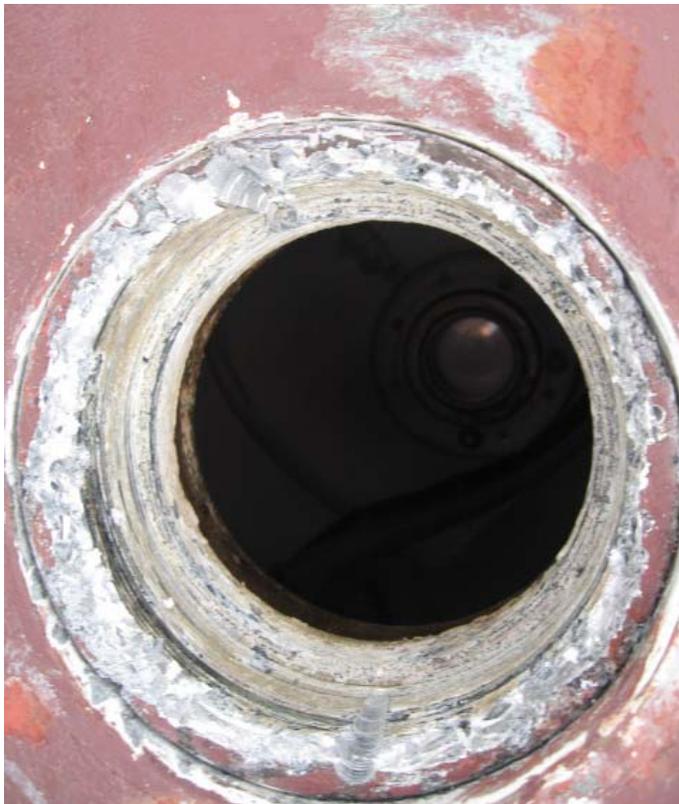
Of course, that left a hole that also had half a bearing to remove, and needed to be ground out to match the OD of the replacement J120 bearing.

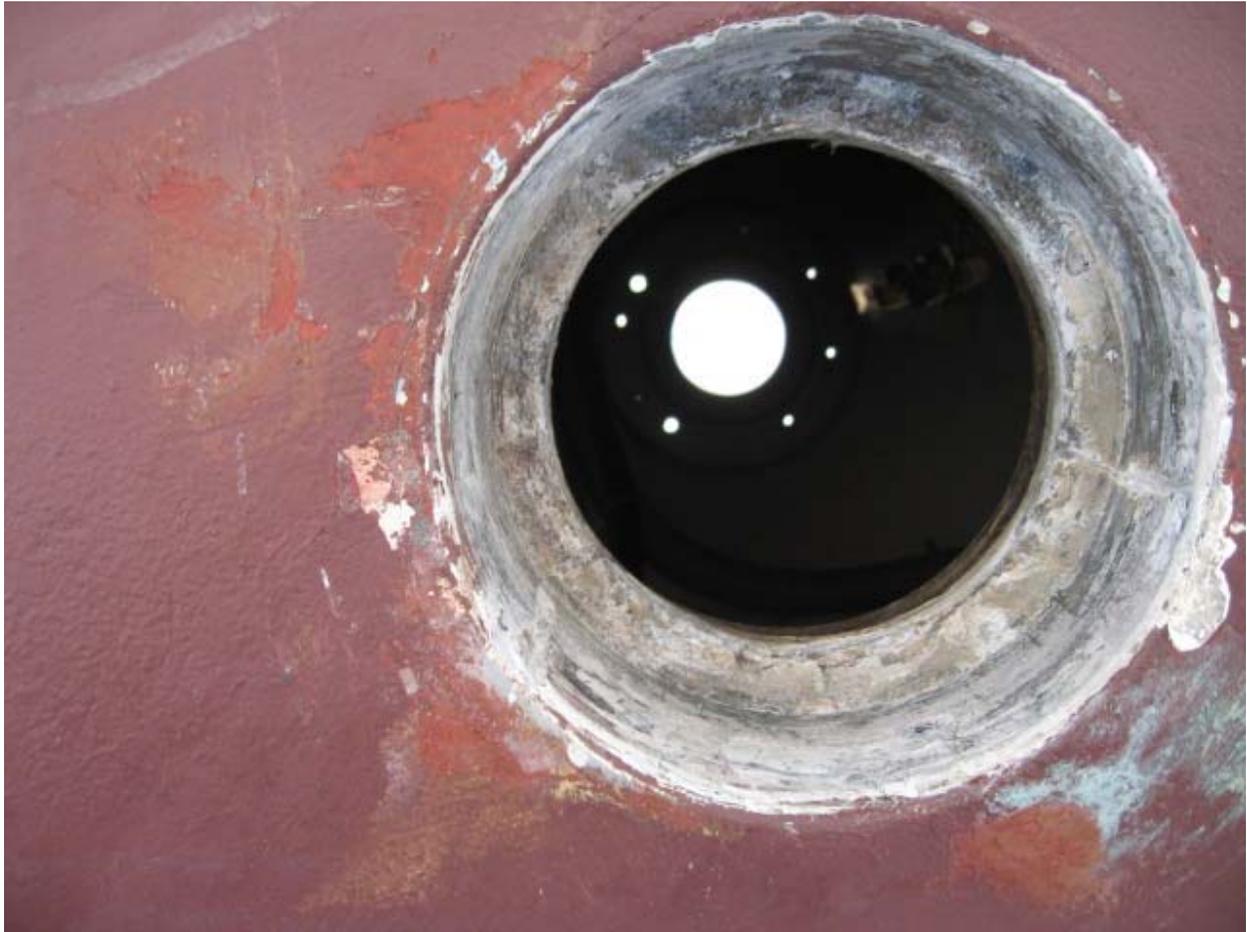
Finally we had the rudder out, and the hull prepared. An inspection of the upper bearing determined that it should be replaced also. This time the J40 bearing was the right size-sort of. The Jefa J40 bearing required another sleeve around the existing Harken sleeve to fit it properly. But it was supplied with the upper bearing and mated properly.

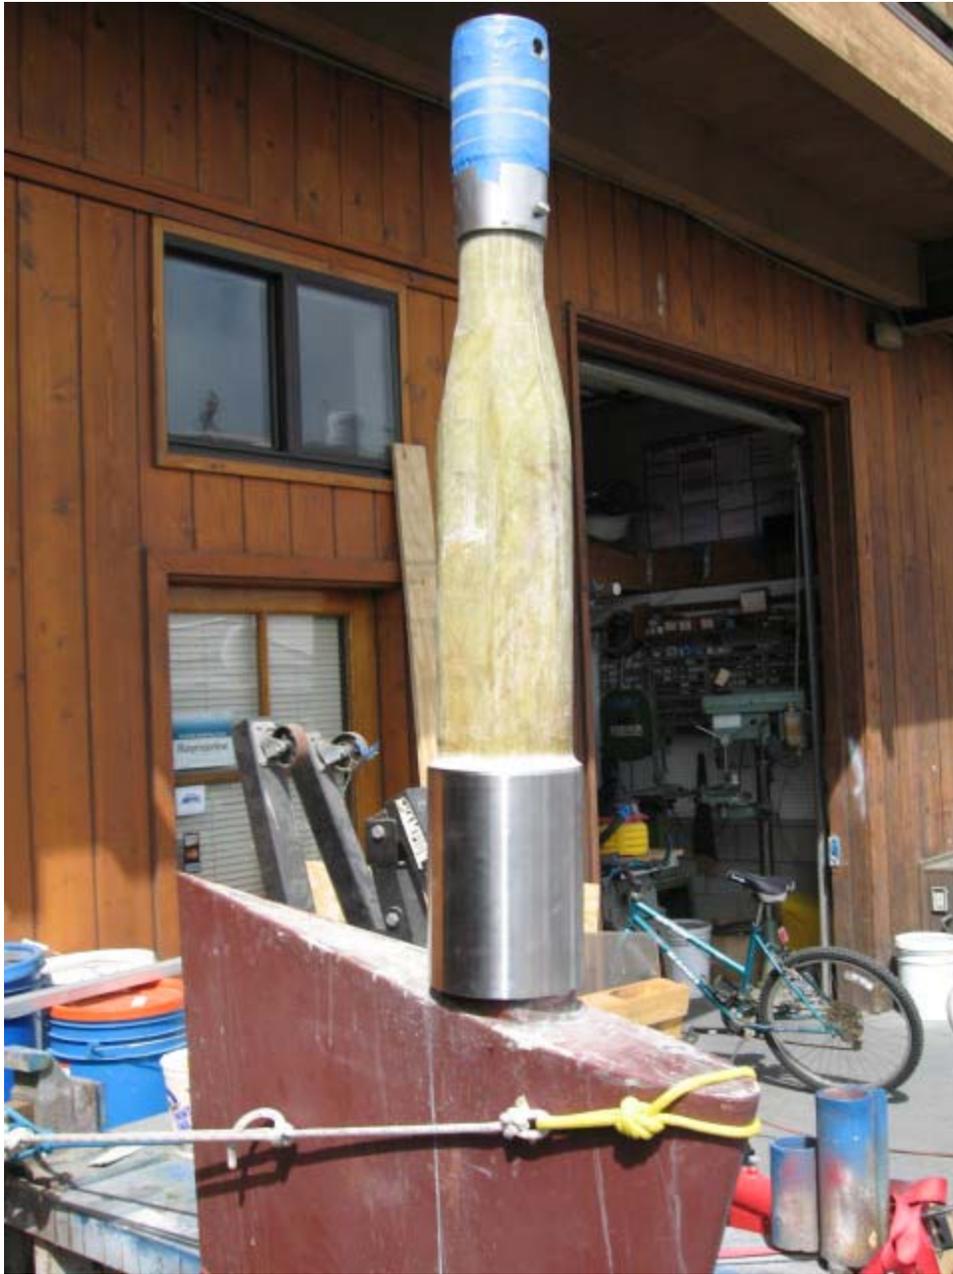
So finally we could get the rudder back into the boat without too much effort.

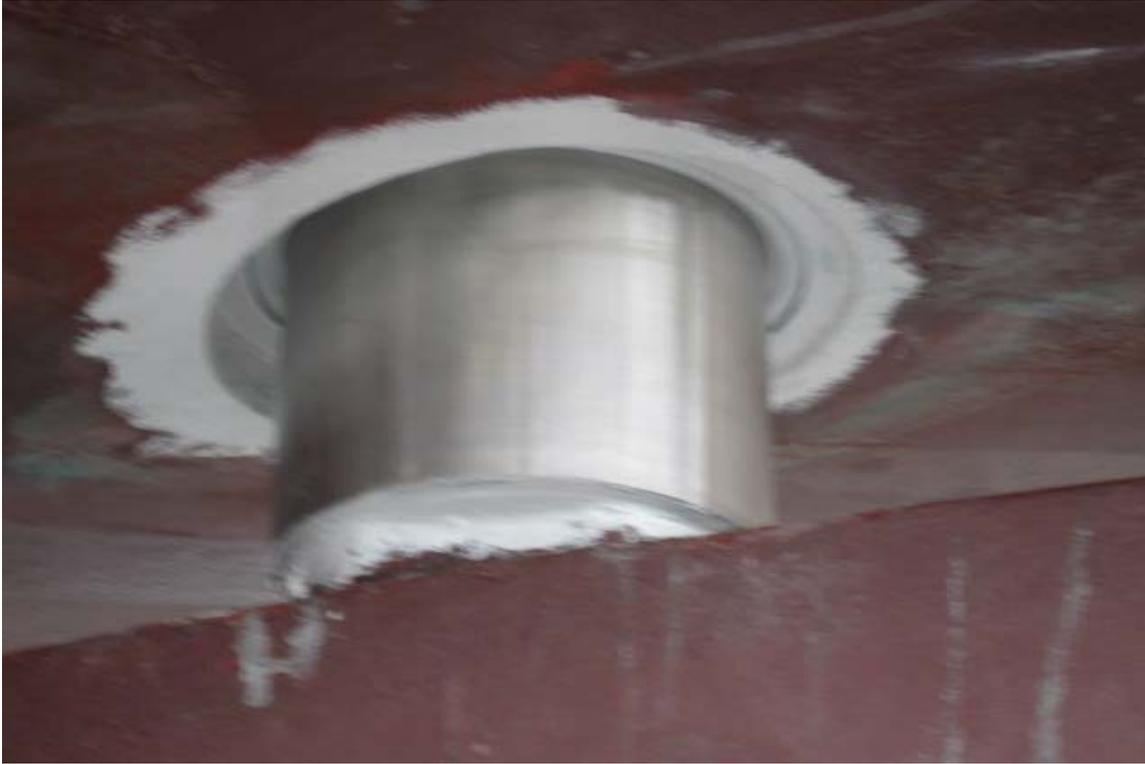
and even the top bearing fit well. Original alignment was not perfect, but was close enough for the new bearings to be centered.

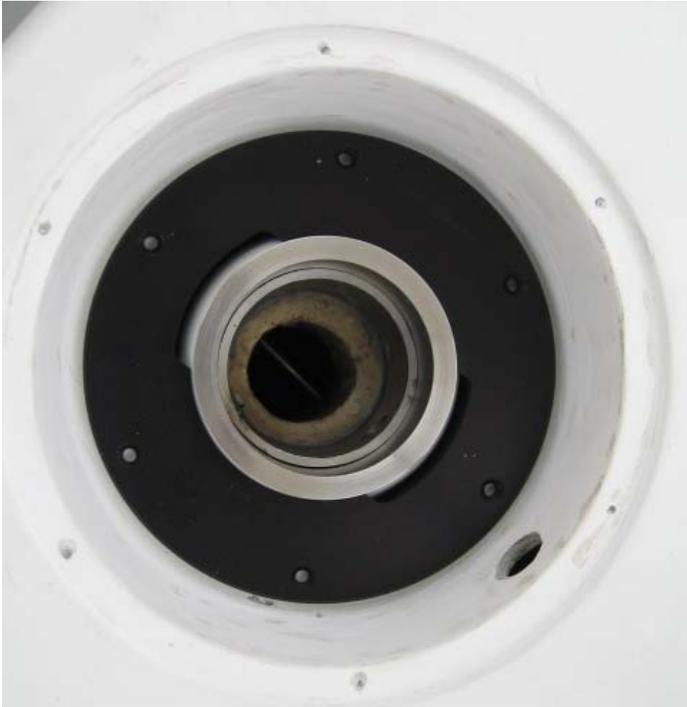
Then all we had to do was put the whole thing back together and test everything. And barrier coat, repaint, ...Fortunately, it all worked and only cost about triple the first bearing replacement.

CONCLUSIONS Assume the worst and hope for the best when you replace the bearing(s). The Jefa bearings are properly sized and supplied, but not all of the J-40 bearings are quite "stock"-so detailed measurements and planning are required before ordering. The new Jefa bearings claim that they are serviceable and that the roller bearings alone can be replaced if necessary-I hope never to find out. But things now do work very smoothly and quietly again.

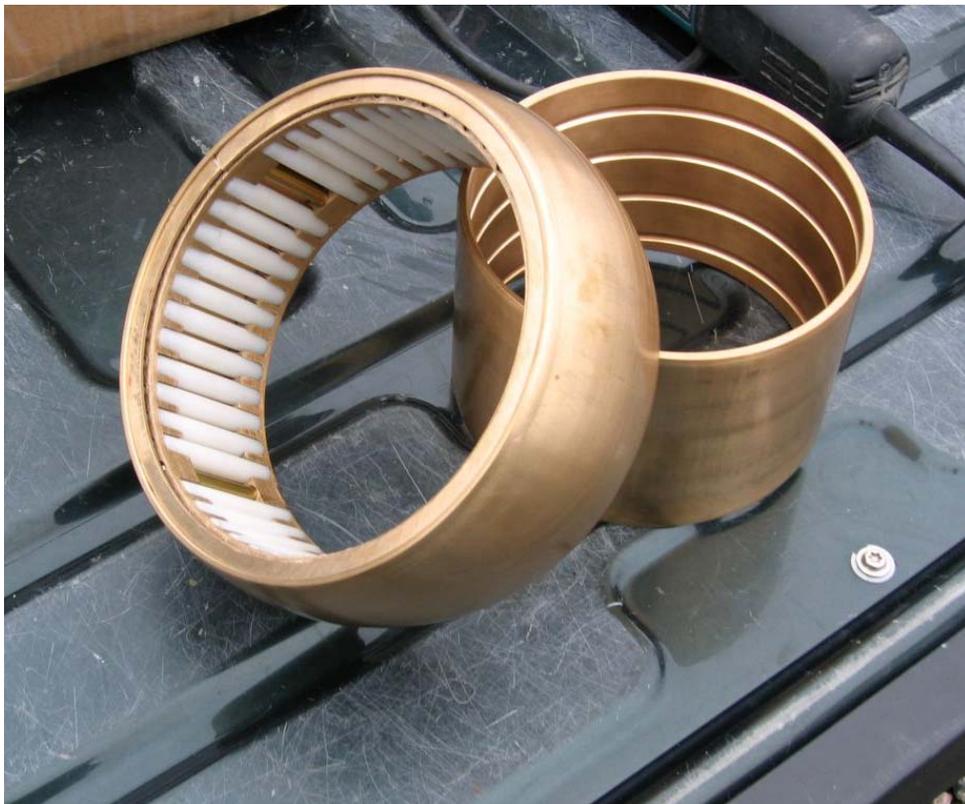
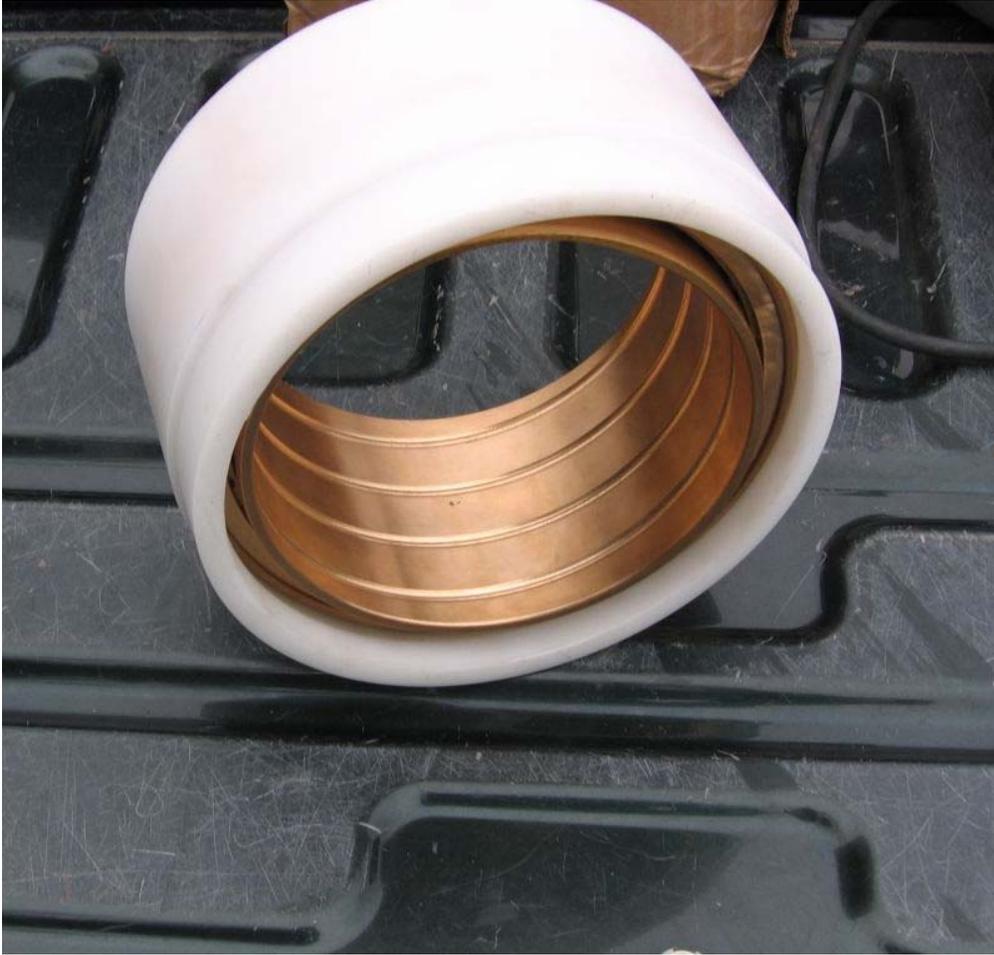
The bearing is made of bronze with delrin needle bearings (see photos 2 and 3). I contacted Mr. James Doe of Shuster and we discussed the bearing at length. I then consulted with the very capable people at my local yard here in Reedville, VA. I also spoke with a yard manager in Deltaville VA who had installed a similar bearing in a J44. My discussions were all positive and resulted in a decision to order the Shuster Bearing. The cost was a bit more than the Jefa bearing. The quote I got on the web without any investigation for the Jefa was \$1800. The Shuster Bearing was just over \$2500. I made the extra expenditure in the hope that I would only have to do this once and that the bearing would last longer than the experiences of others.
